# Manhole Inspection Summary

Manhole # S57A\_\_016MH

Insp Date: **6/25/08 10:06 AM**

**Location** Address: **201 n haven st**

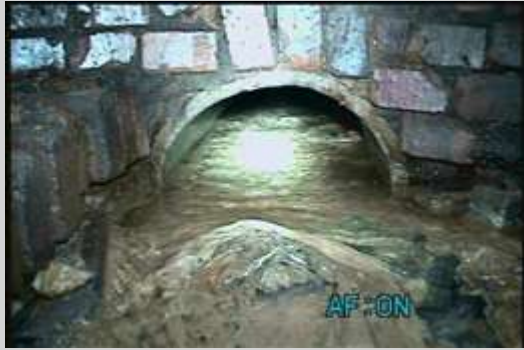
9 O'Clock Inflow

12 in. Circular Gravity Sewer  
Pipe In @ 9 O'Clock

Infiltration: **None** Pipe Seal Cond: **Unknown**
